Nature:		Personnel: ArcelorMittal			Date: June 21, 2010	
			□ Contractor		our: 3:15PM CST	
x Near Miss			Other			
			_			
Arcelor facility:	Sector:		Sub sector:		Country:	
ArcelorMittal LCNA Indiana	LCA/LCNA		No. 1 EAF Steel		LICA	
Harbor Long Carbon	LCA/I	LUNA	Producing Shop		USA	
Activity:	Steel Producing					
CEO:	P. S. Venkat					
	•					
Contractor:			Activity			
Contractor Iron Workers			Erection of Scrubber Structure			
Nature of the accident/incident			Key words			
Fallen Hand tools.			Personal Protective Equipment Save/Tiered Work Activities

Preliminary Report - Subject to change upon further investigation

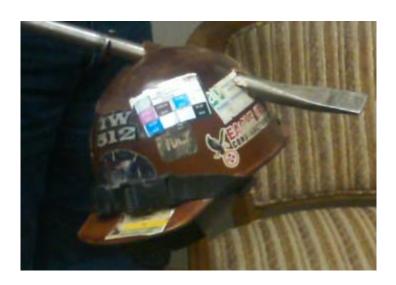
Photograph:

As the co-worker was maneuvering the basket of the aerial lift, and properly tied off, his safety lanyard got caught on his tools (attached to his tool belt) and flipped the slever bar sideways in its sheath – causing the bar to flip out and fall. The bar fell and struck the hard hat of the employee below – piercing through the hard hat as depicted in the attached photo. The hard hat fell off the employee, and fell and additional distance to the ground below. The employee was not injured.

- 1. An immediate safety stand down with the crew to discuss the incident and implement a number of the corrective actions listed.
- 2. Vendors who manufacture slever bar holders and other such tool holders will be contacted to discuss design changes to prevent tools from being dislodged from holders.
- 3. Only tools essential to complete assigned tasks will be carried in tool belts.
- 4. Given the potential for slever bars, spud wrenches, etc to become dislodged from their holders, if any unprotected overhead work requires use of such tools, employees will not be present below unless a protective deck or safety net system is installed.

- All employees have been instructed on the importance of full communications and heightened safety awareness when working in areas where overhead fall object hazards exist.
- 6. Met with ArcelorMittal Indiana Harbor Long Carbon Health and Safety Department to discuss the incident and get input for corrective actions and a joint effort to address this safety concern among contractors and company employee activities.

- 1. Communicate an initial Tool Box Safety Discussion for all its employees on the importance of PPR hard hats in particular.
- Communicate an expanded Tool Box Safety Discussion to the same employees relative to PPE, tiered work, and potential for dropping tools – whether it be from tool holders, other structures such as EOT Cranes, Aerial lifts, etc., - with a strong reminder that all loose tools must be managed and secured properly.
- 3. Communicate this event and corrective actions to other contractor firms supporting ArcelorMittal Indiana Harbor Long Carbon.
- 4. <u>Seek feedback via this communication from other business units across ArcelorMittal</u> operations relative to best practices.
